A Lipan Apache Mission

San Lorenzo de la Santa Cruz · 1762-1771

By Curtis D. Tunnell and W. W. Newcomb, Jr.

THE ARCHEOLOGICAL INVESTIGATION

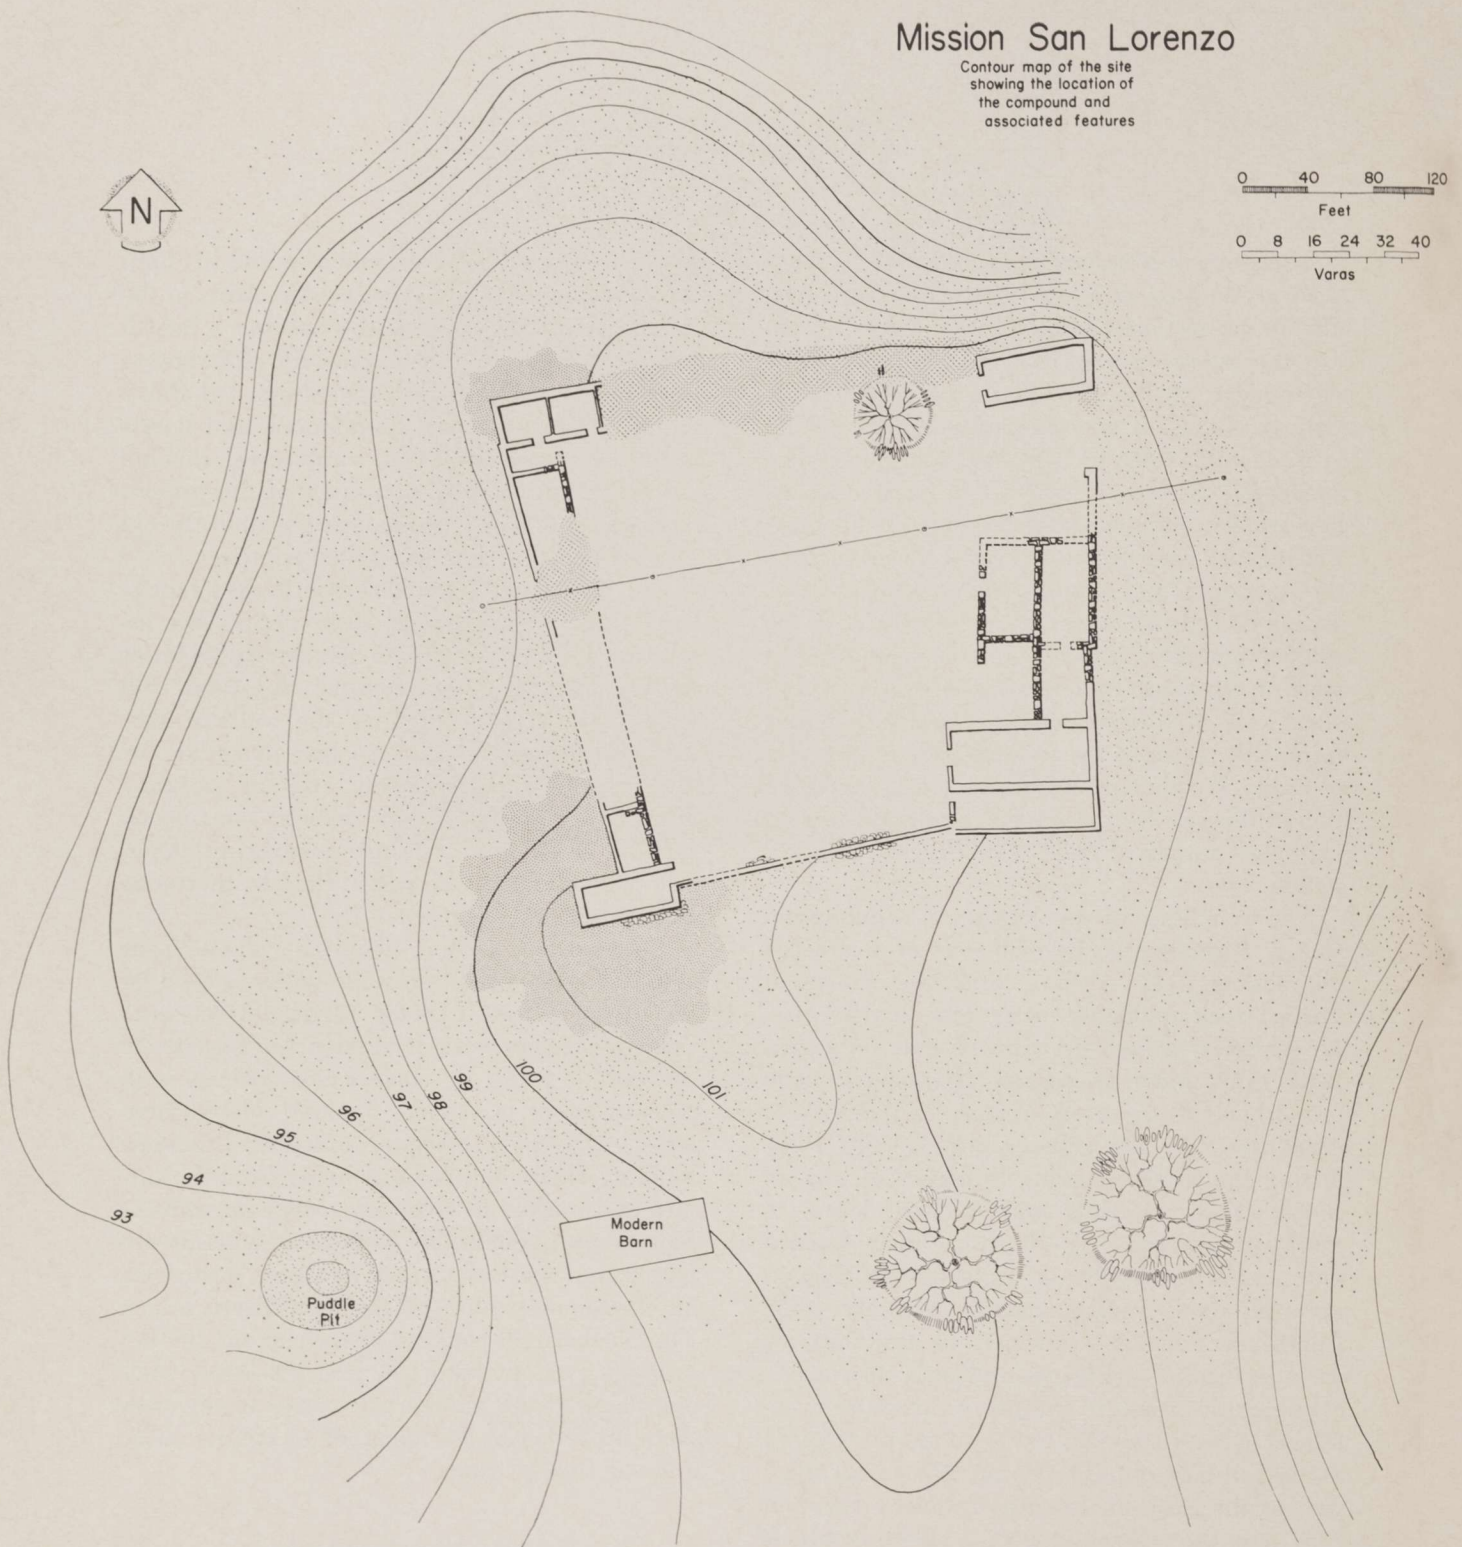
Fig. 1. Contour map of the mission site.

Contour map of the site
showing the location of
the compound and
associated features

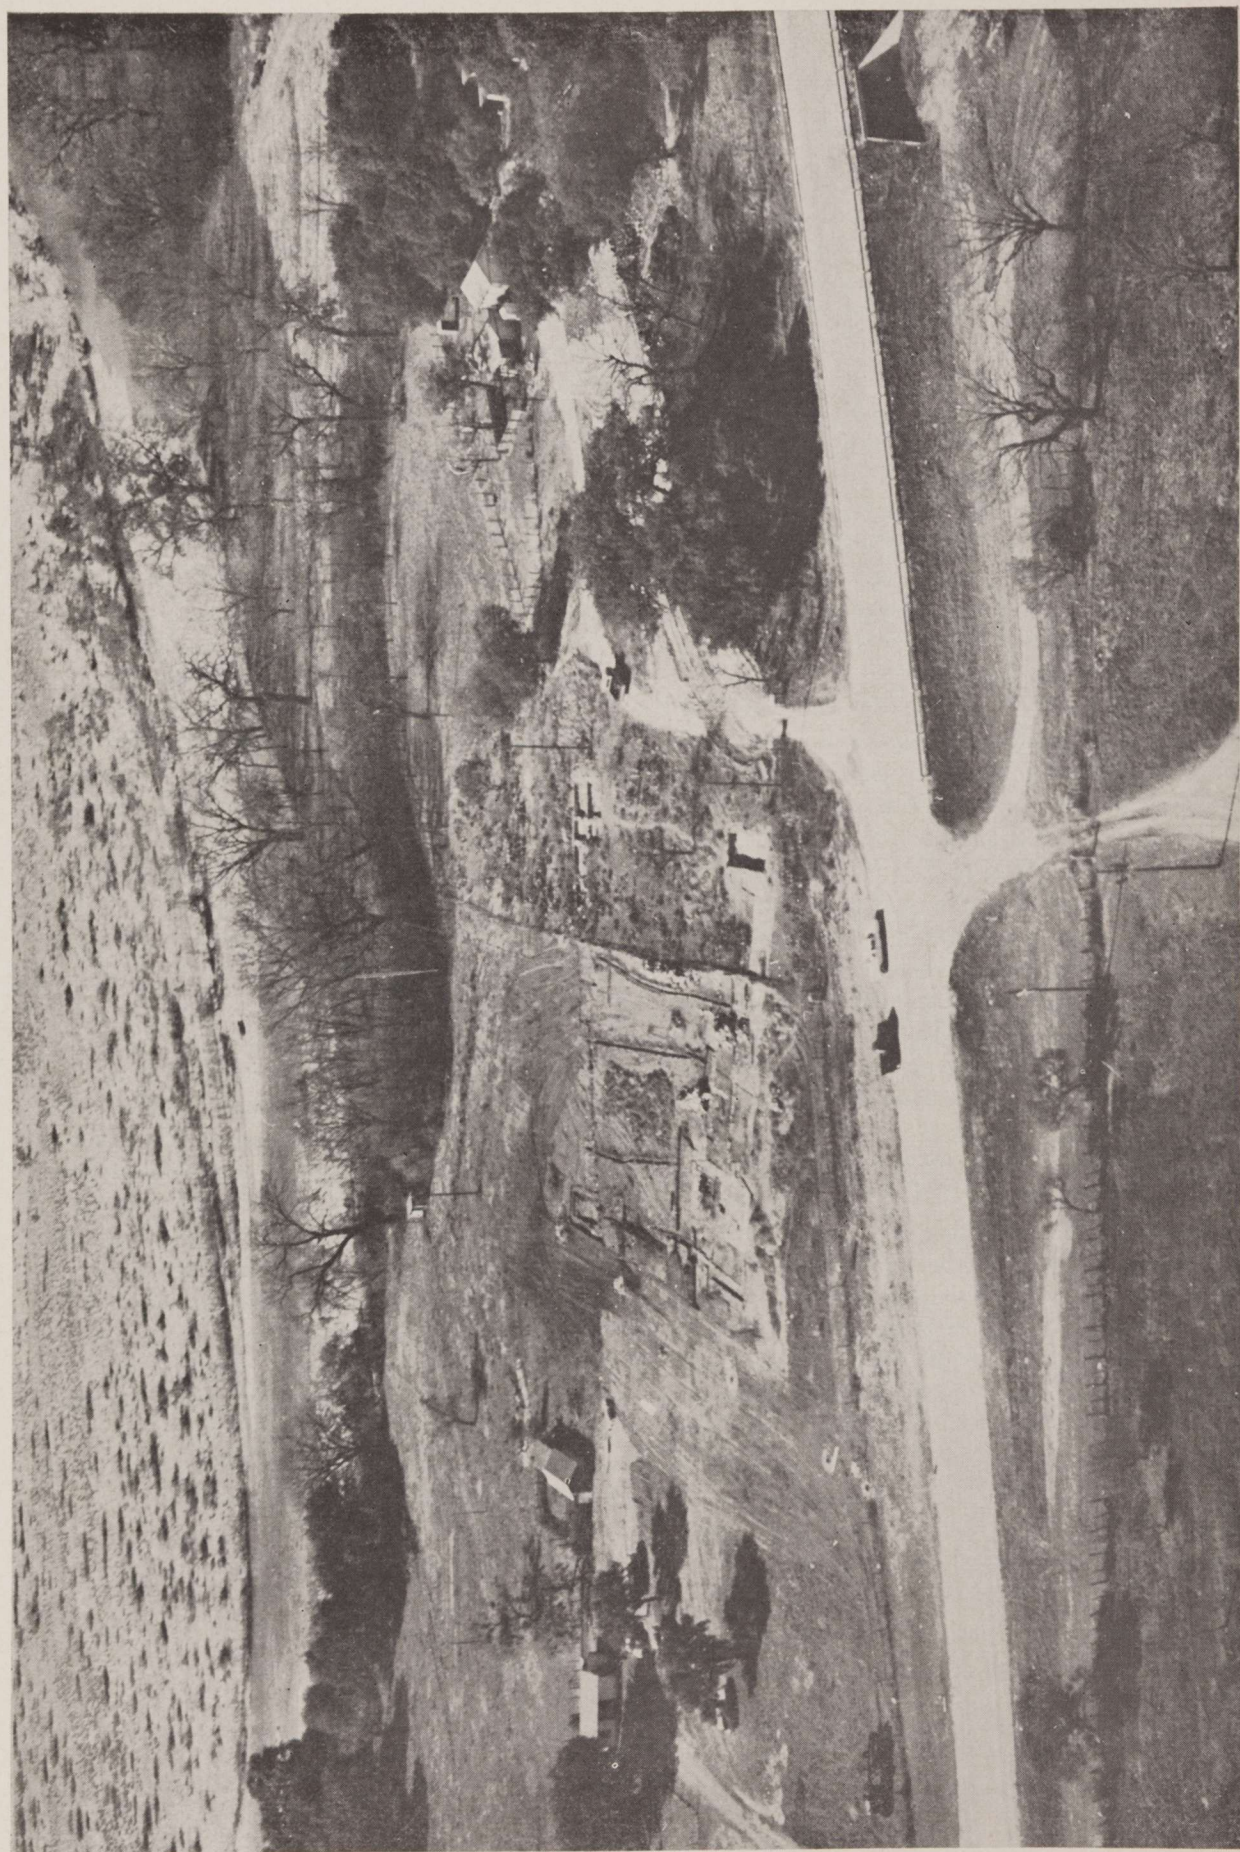
Fig. 2. Aerial view of the site, taken during excavation, looking toward west. The Nueces River is in the background, and spring-fed tributary is to the right.

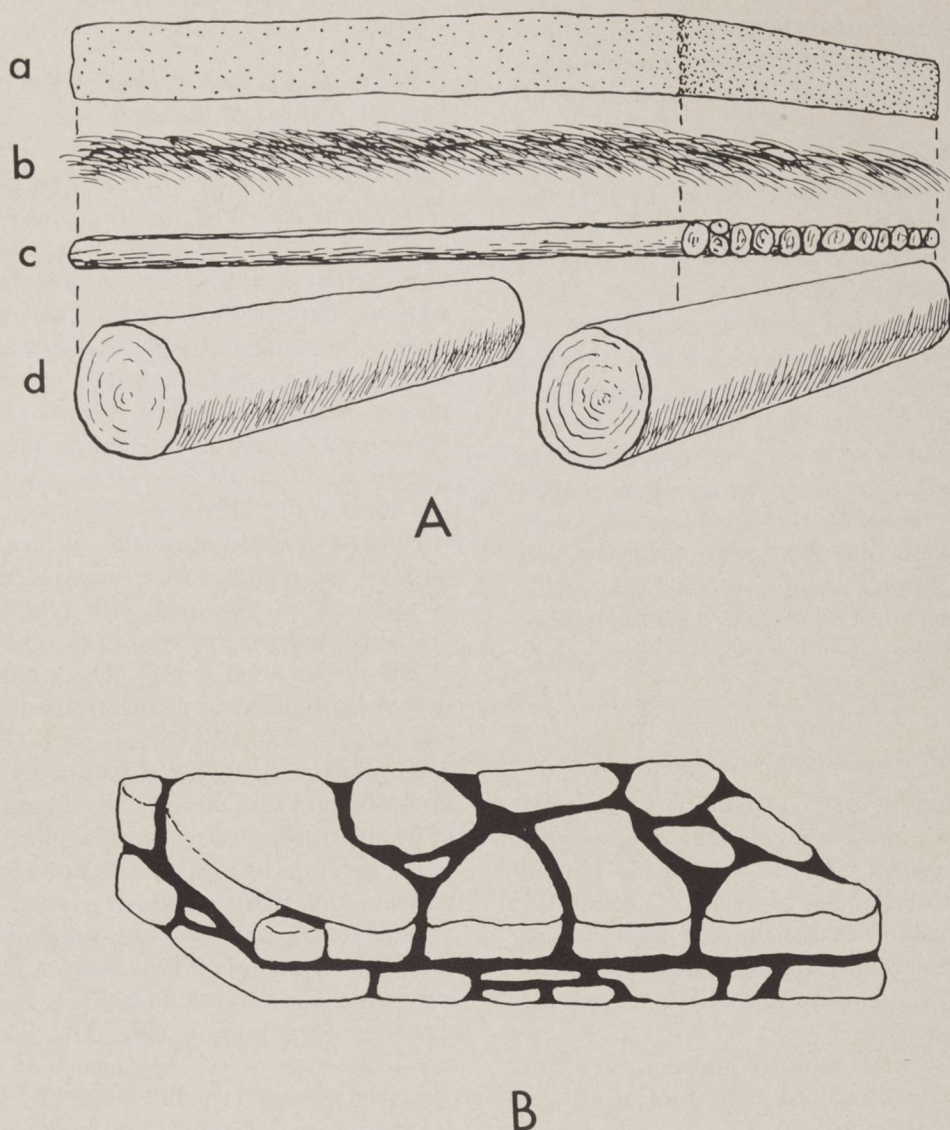
Fig. 5. A. Details of roof construction: a, puddled adobe; b, grass; c, savinas; d, vigas. B. Details of stone wall construction.

The small cross pieces (*savinas*) used in the roofs were usually about 3 cm. in diameter, and complete stems, not split fragments, were used (Fig. 5, A). Juniper was the wood most commonly selected for these cross sticks, but a few stems of unidentified shrubs were found. The original length of these *savinas* is not known. Only short broken fragments were recovered.

Local grasses were gathered and used between the sticks and the puddled adobe in the roofs (Fig. 5, A). Charred mats of this grass were found preserved in some structures, and impressions of grass stems appear in the undersurface of the puddled adobe roof material. No identifications of the grasses have been obtained.

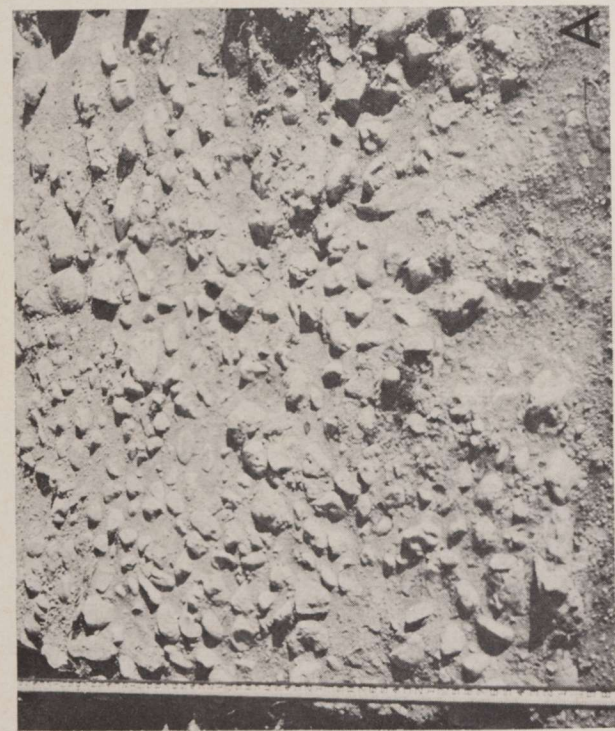
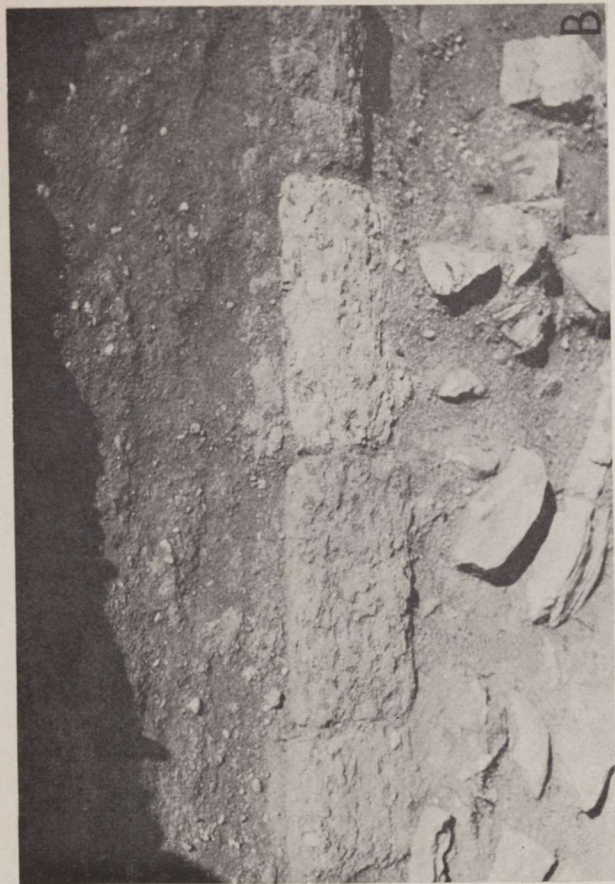
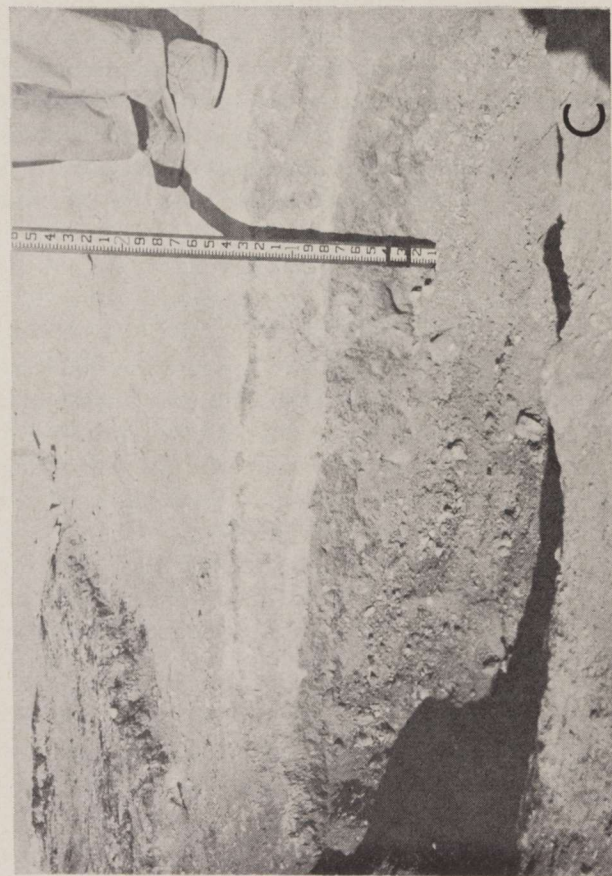
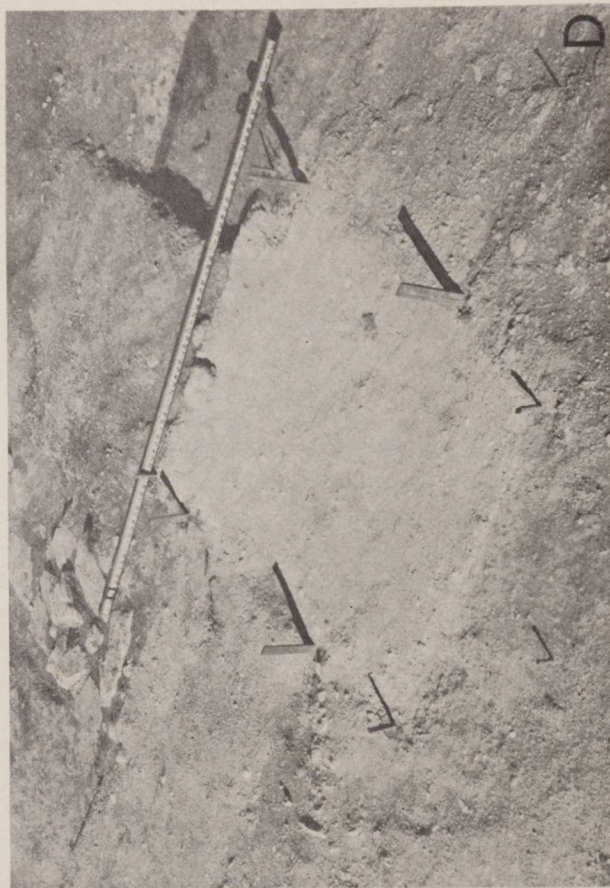
Fig. 6. Excavations in the southeast corner of the quadrangle. A, cobblestone walk west of Structure 2; B, light and dark adobe bricks in south quadrangle wall (note reinforcement outside the base of the wall); C, superimposed adobe floors exposed inside a burial pit in floor of Structure; D, adobe threshold leading through north wall of Structure 2 into Structure 5.

Puddled adobe was used as mortar in setting the bricks in the walls and filling cracks between the bricks. It was also used to form a threshold between Structures 2 and 5 (Fig. 6, D) and as a plaster covering for interior features in Structures 7, 10, and 12.

Floors: Structure 2 had two superimposed adobe floors (Fig. 6, C). The western end of the upper floor (No. 1) was cleared of debris except for a few patches of burned roof material. The surface elevation of this floor ranged from 99.49 to 99.73 ft. Toward the eastern end of the structure, the upper floor sloped upward sharply onto what apparently had been a raised area (sanctuary) resting on a hard-packed gravelly soil base. Unfortunately, the bulldozer had removed about 18 feet of the eastern end of the upper floor and the entire sanctuary area. Composed of light tan adobe with small river gravels, the floor averaged about 3 cm. in thickness, and its upper surface was smooth and hard-packed. At least twelve burial outlines (several of which intersected) could be seen in the surface of the upper floor; most of these were later excavated. A lower floor (No. 2) was detected in the edges of the grave pits, and was separated from the upper floor by about 3 to 9 cm. of dark brown, very compact clay which apparently was placed over the lower floor as a base for the upper floor. The lower floor was not cleared; it was studied only in the grave walls. It, too, was composed of light tan adobe with river gravels. Its average thickness was about 3 cm., and its upper surface elevation

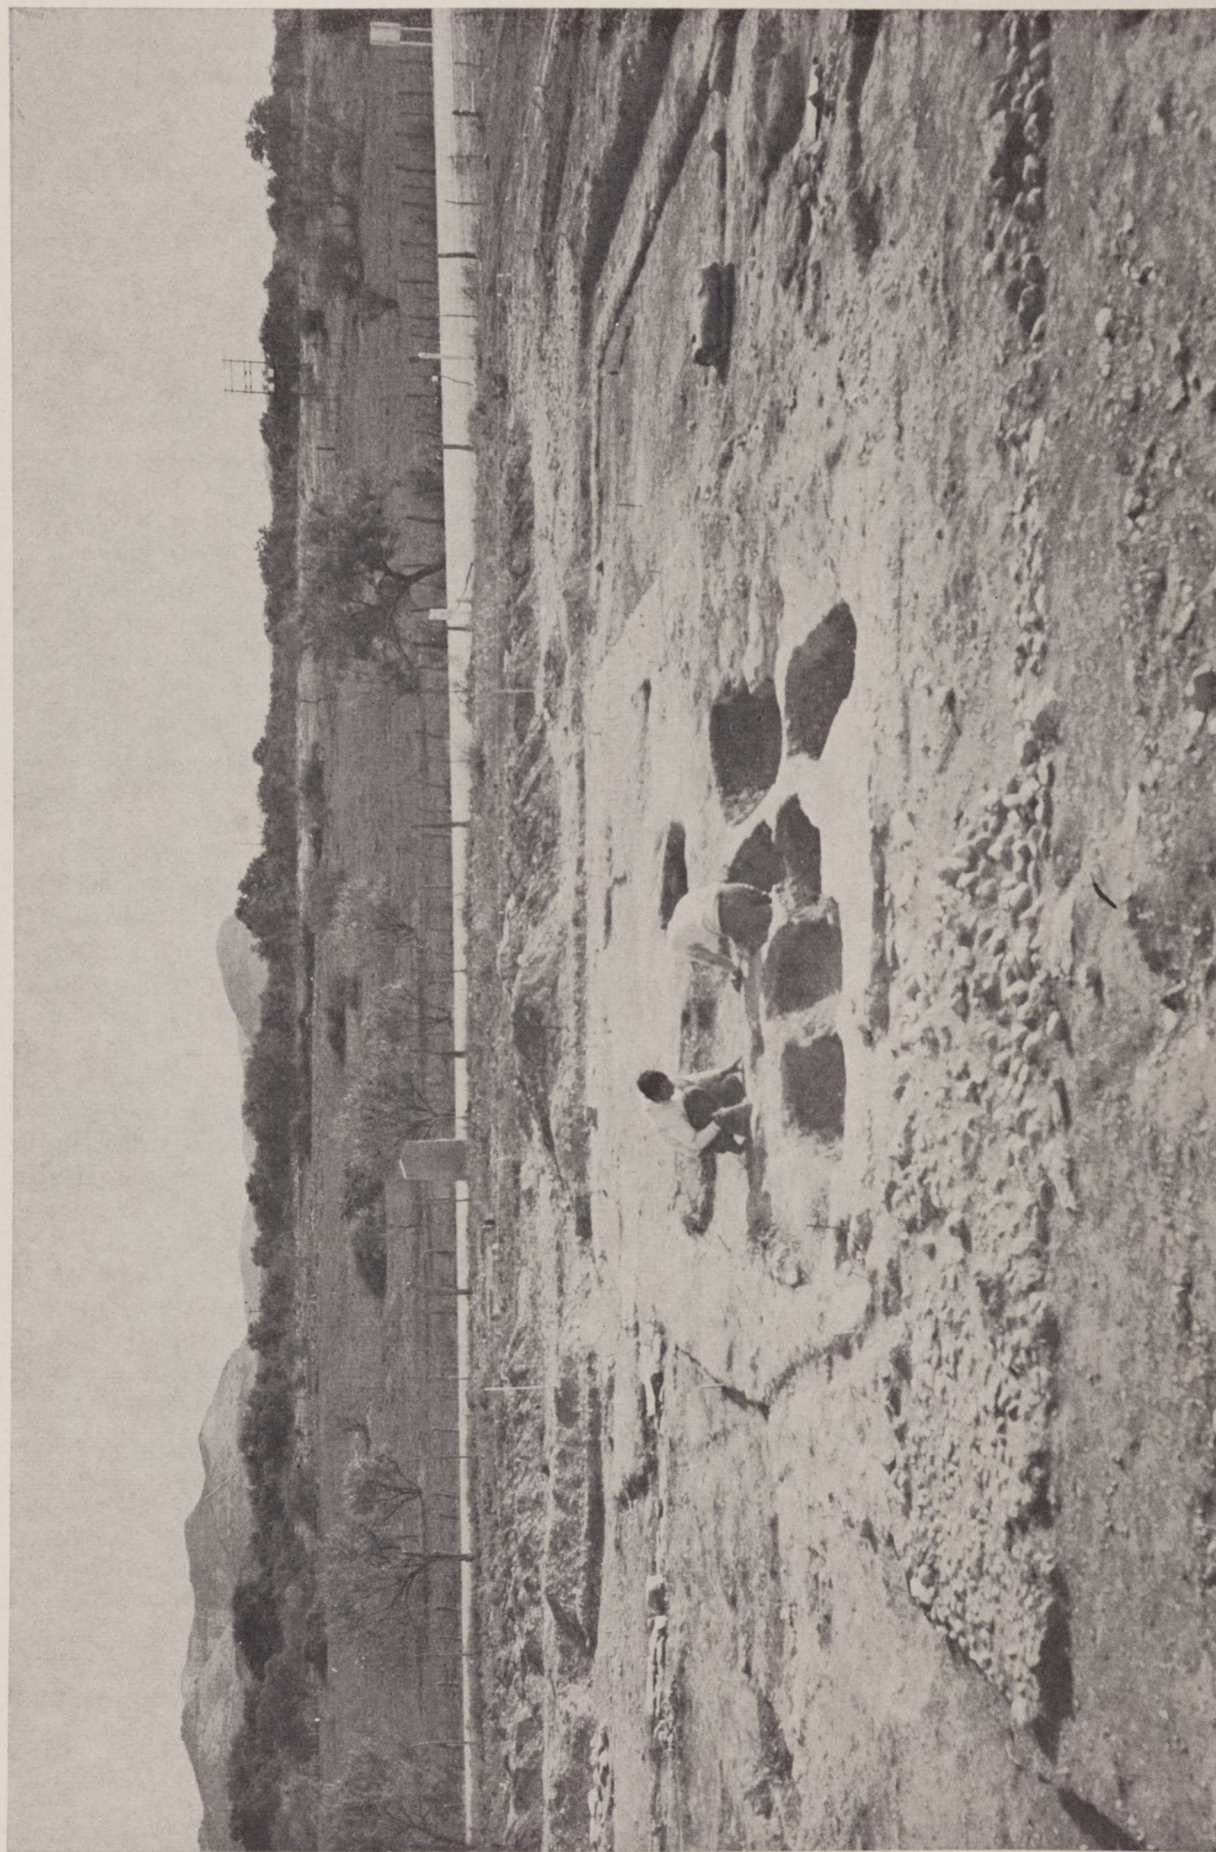
Fig. 7. Excavation of southeast corner of quadrangle showing Structure 2 in center with Structure 8 to the right and Structure 5 to the left. Note burial pits through door of Structure 2 and portion of cobblesone walk in front. Looking east.

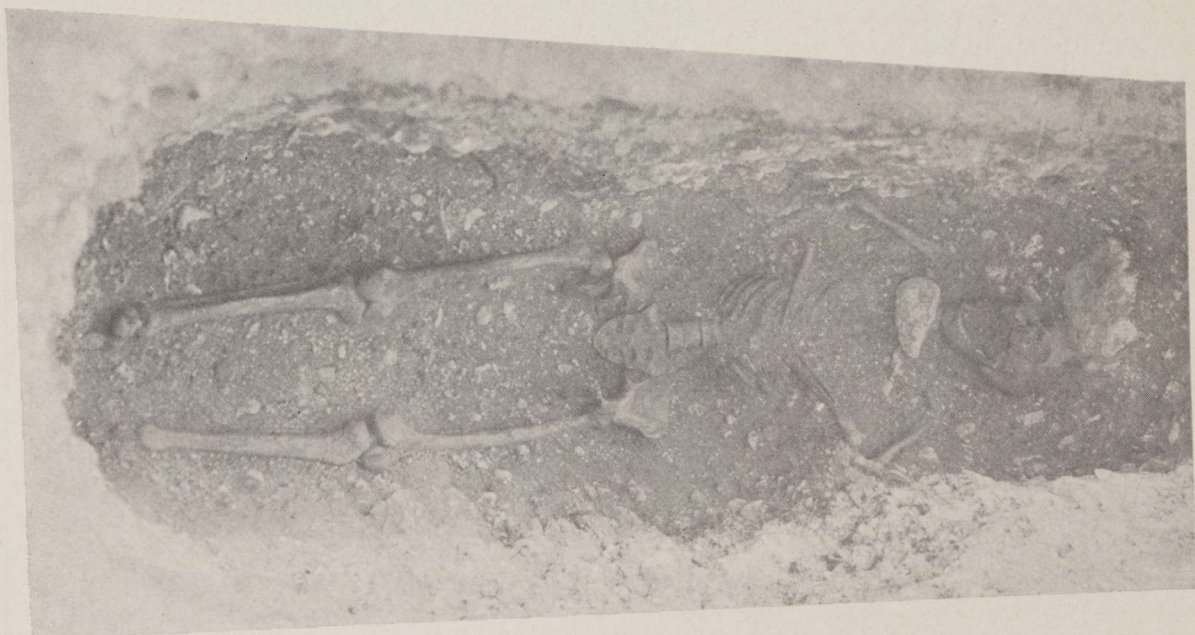
Fig. 10. East-west cross section of Burial 1 (top) and detail of burial.

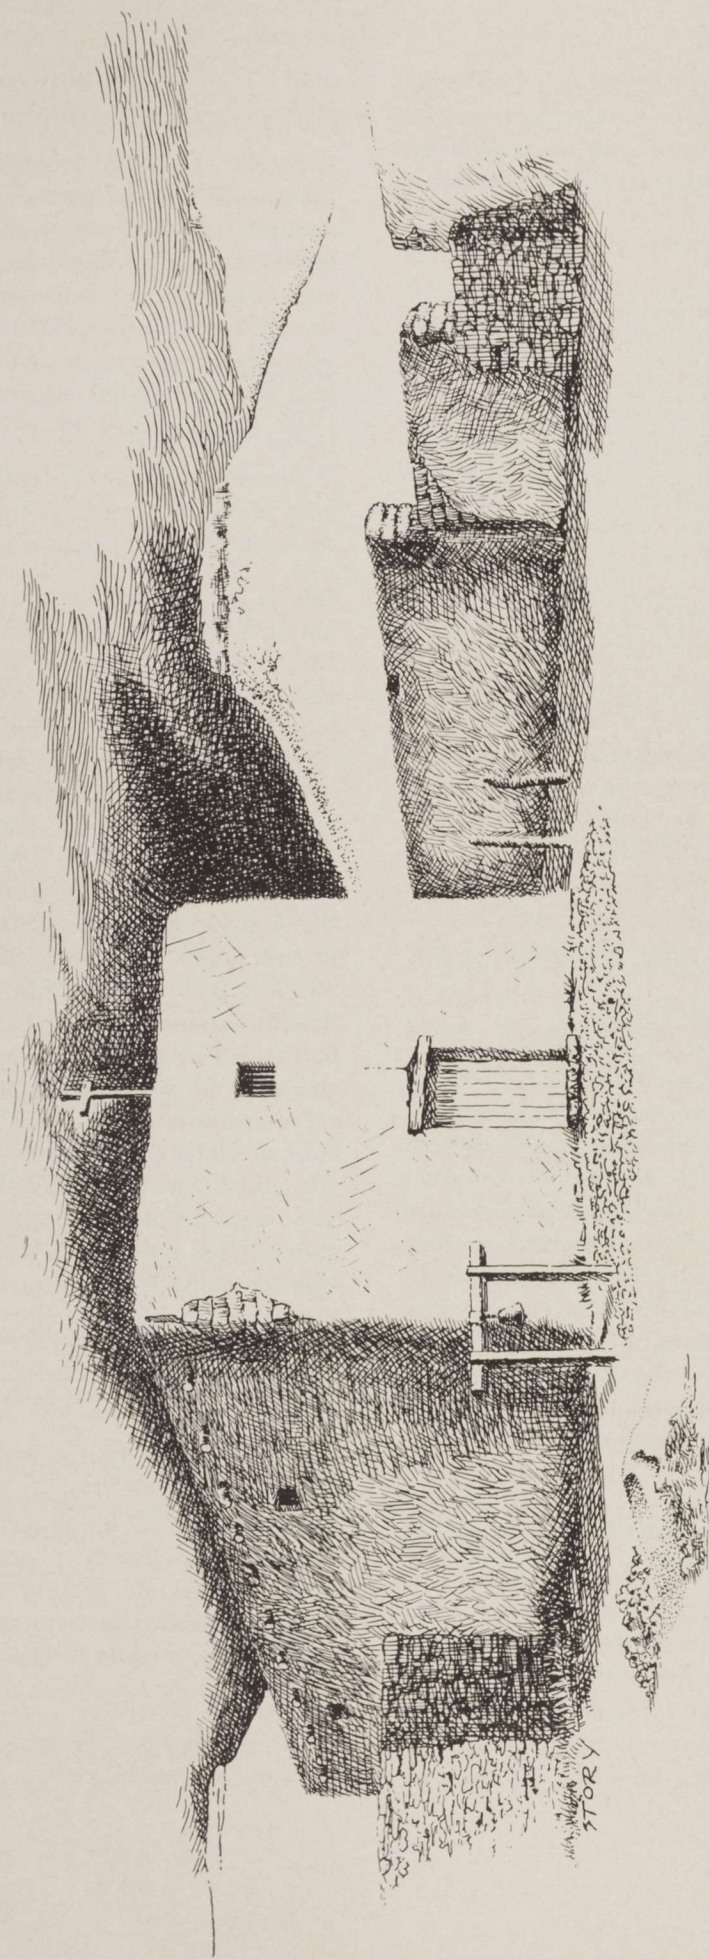
Fig. 11. Artist's reconstruction of Structure 2 in southeast corner of quadrangle. Looking southeast.

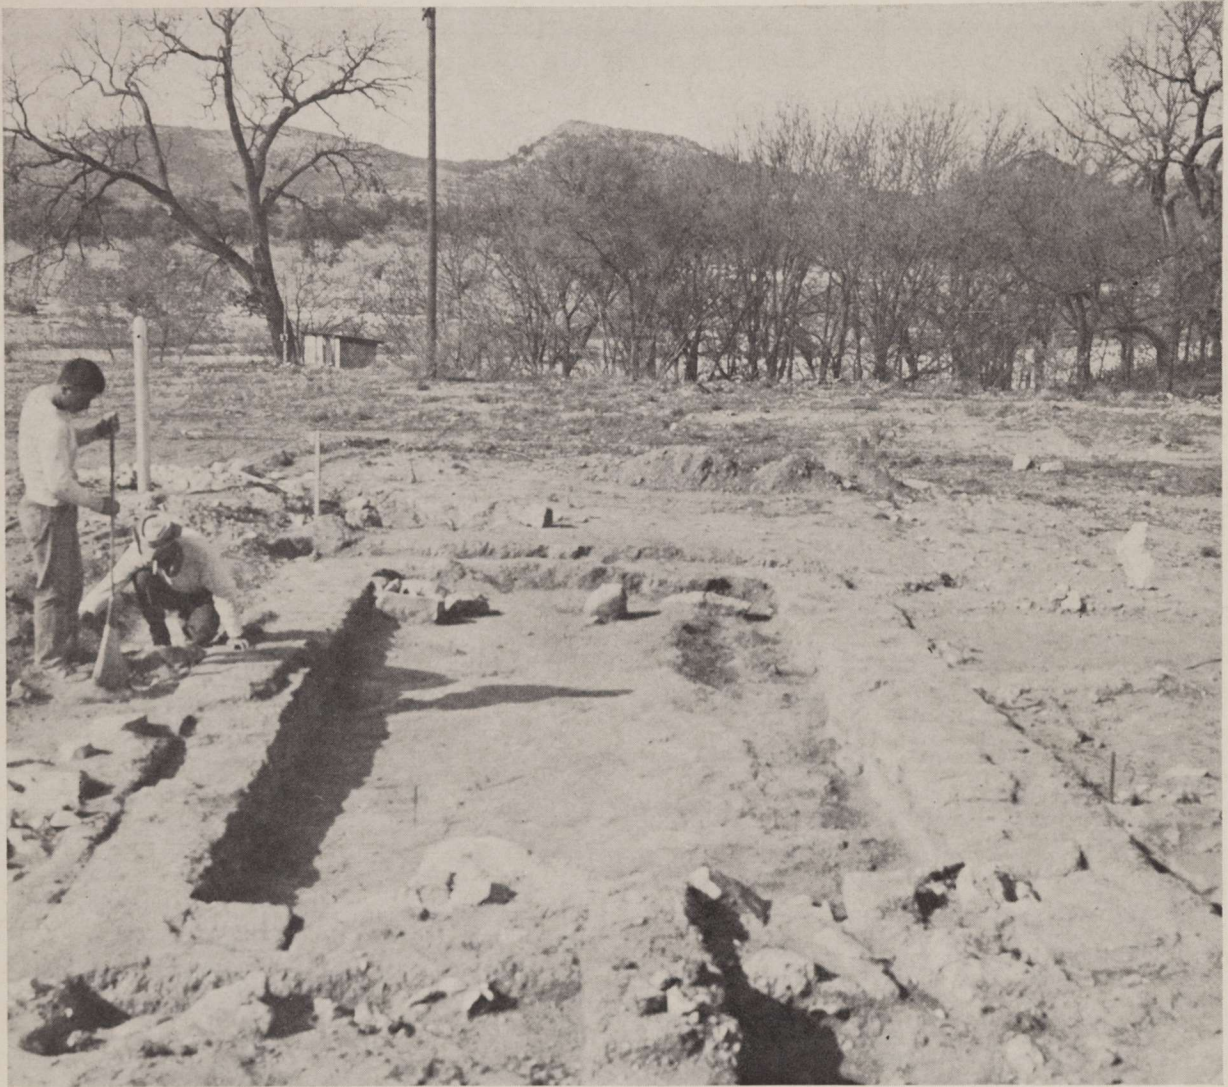
Fig. 13. Excavation of Structure 7. A, cleared down to floor, looking west; B, feature against south wall and lying on floor.

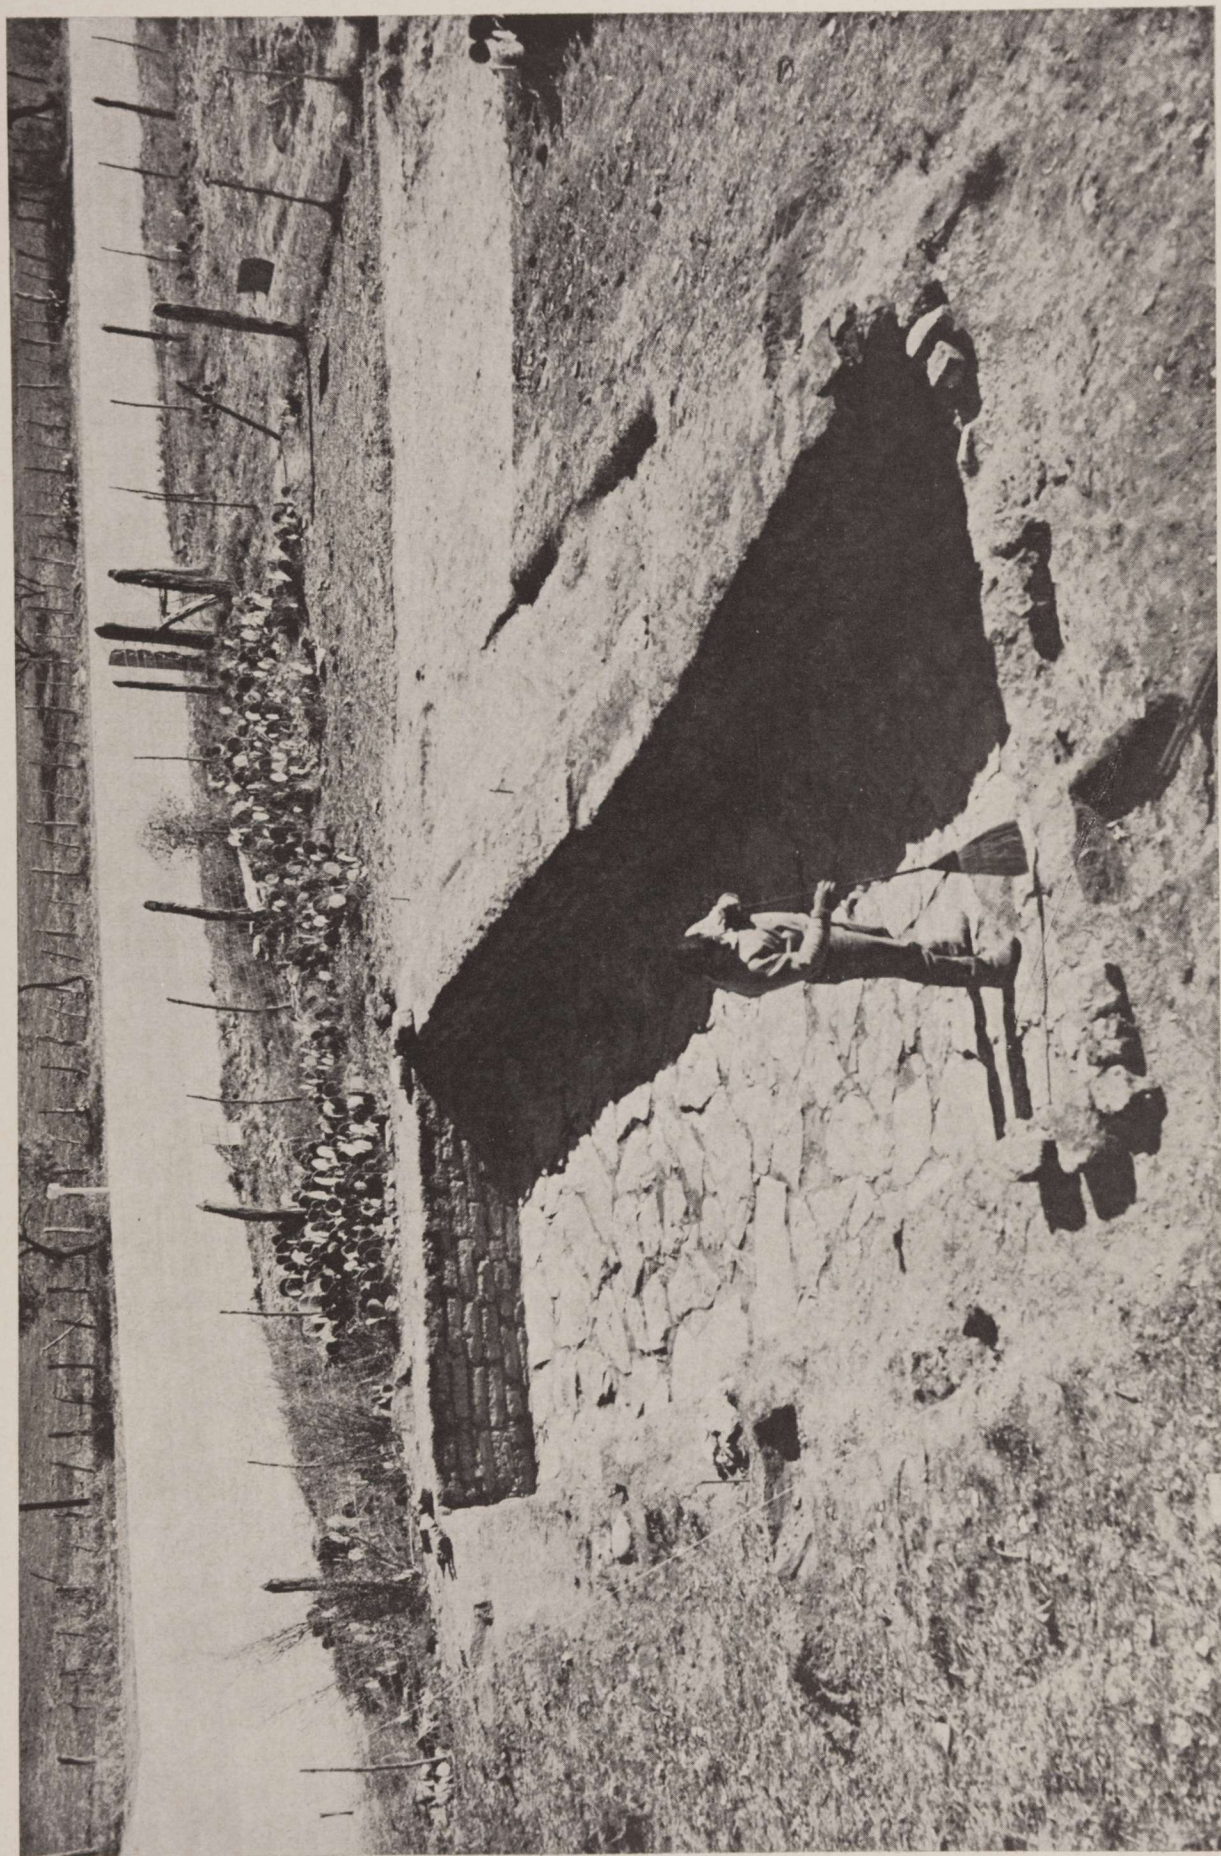
Fig. 16. Excavation of northeast corner of quadrangle showing Structure 10 with its cobbles floor. Looking east.

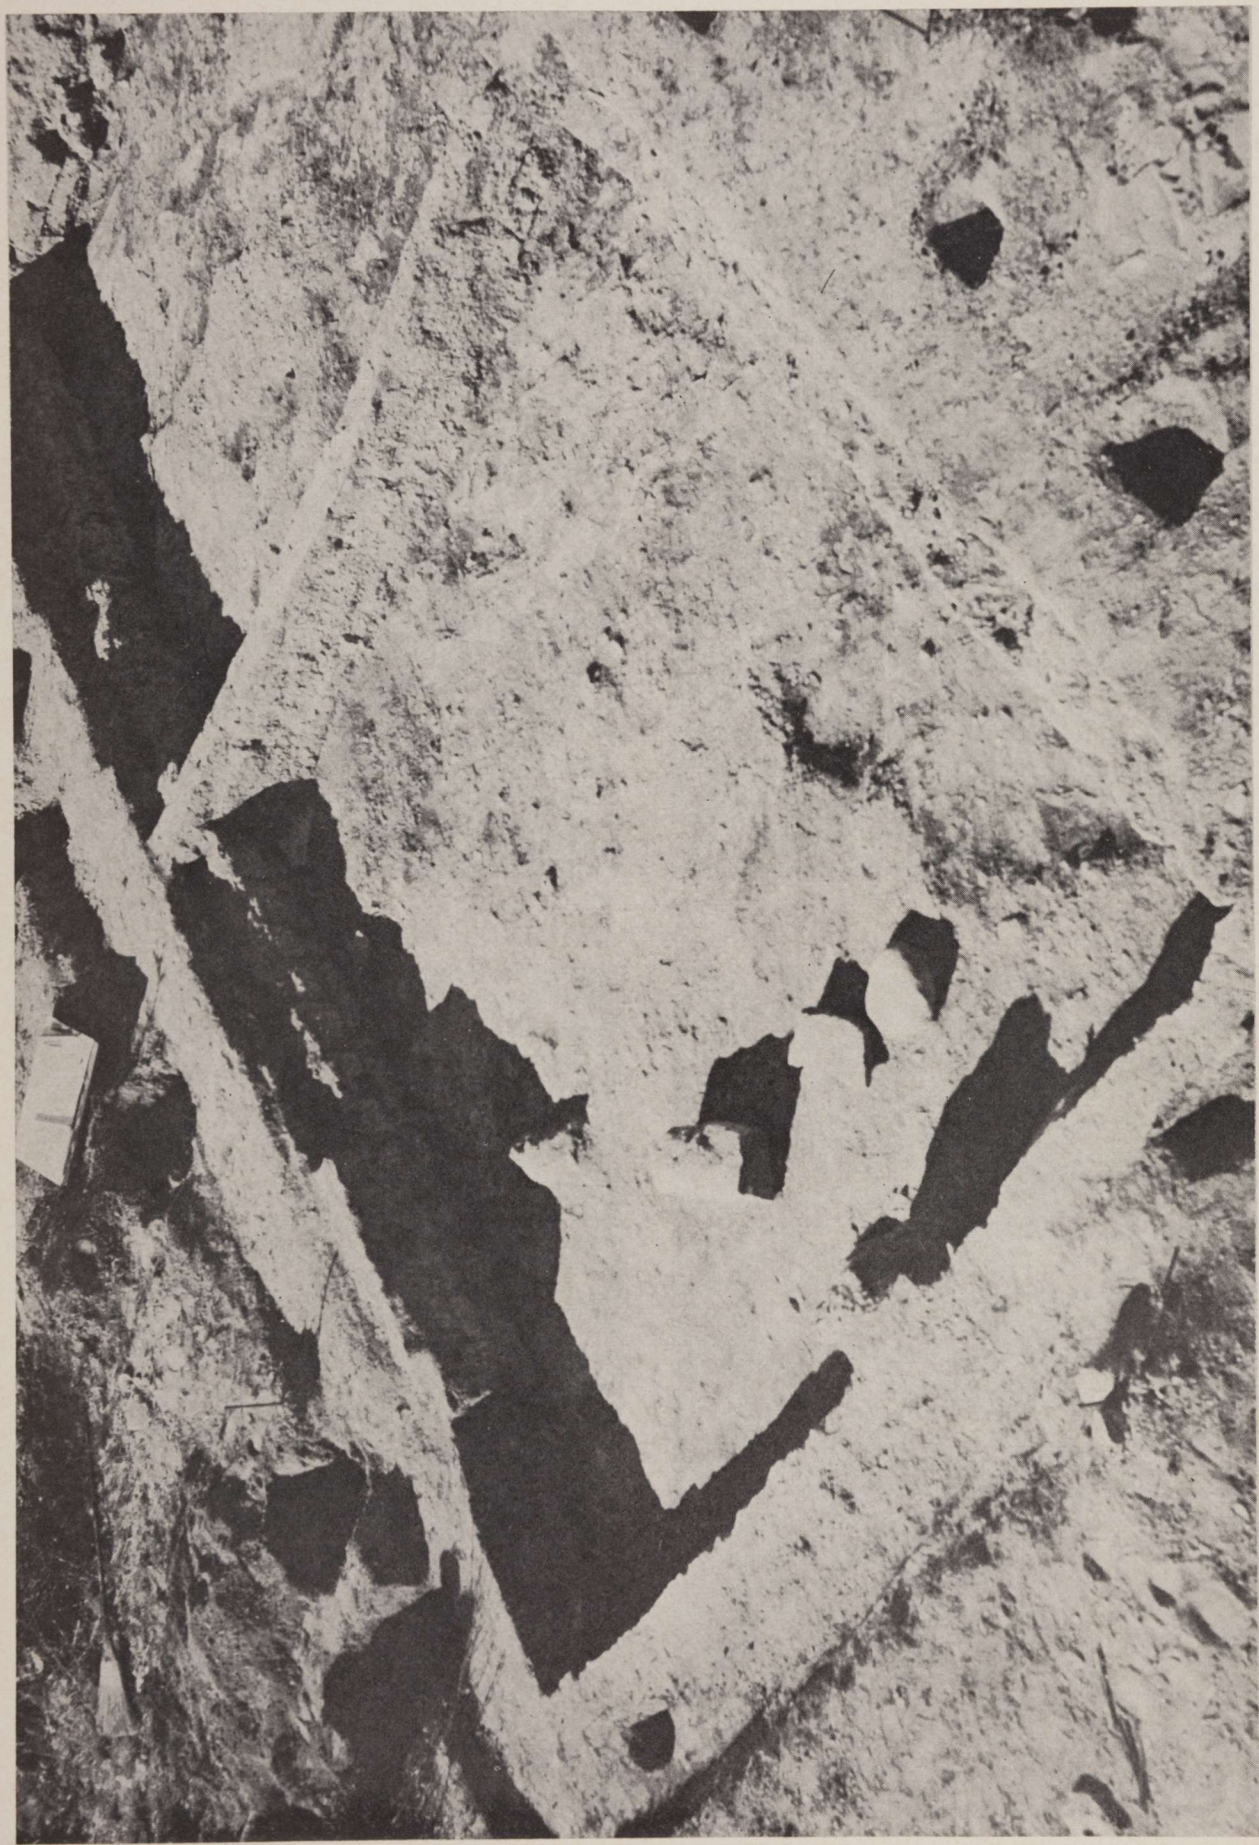
Fig. 22. Structure 12 after excavation, showing features on adobe floor. Looking southwest.

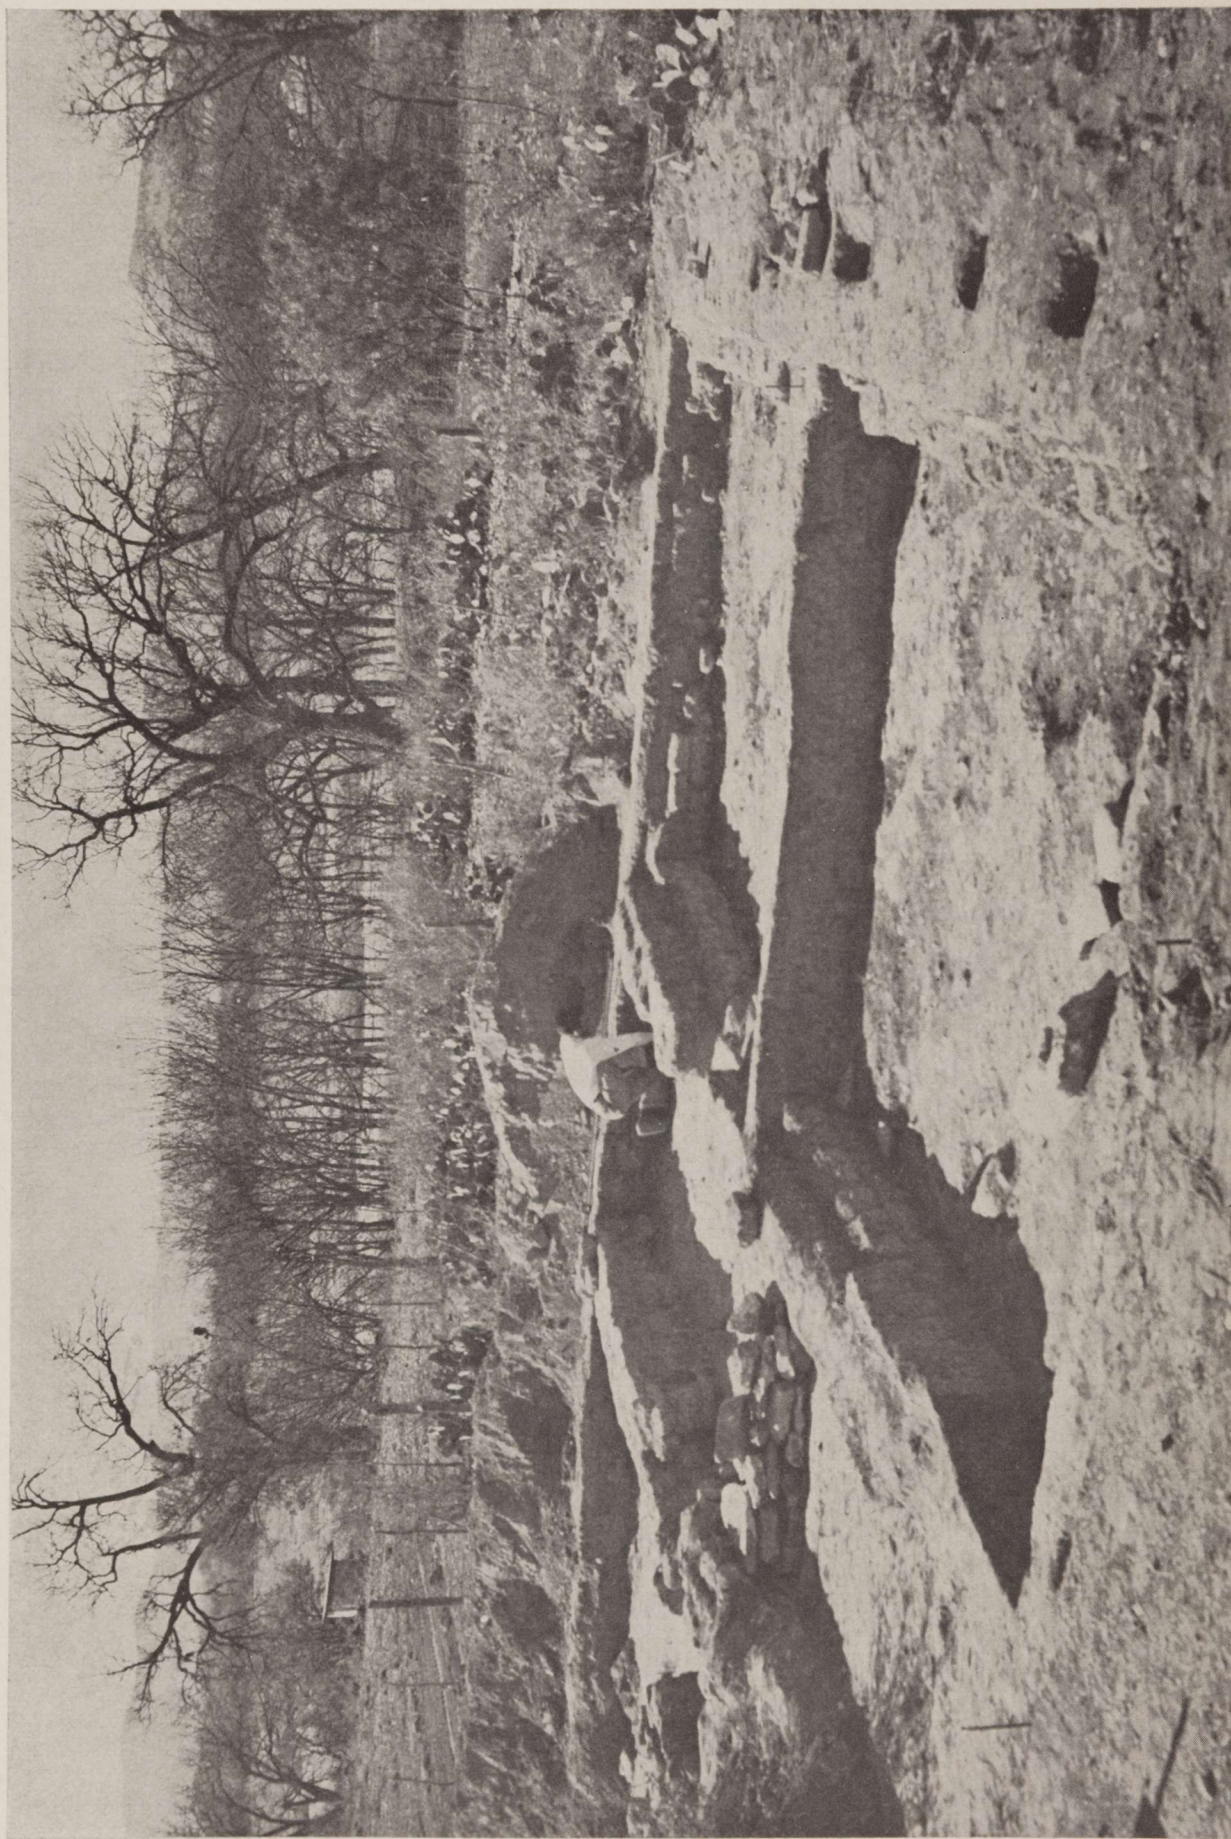
Fig. 25. Excavation of northwest corner of quadrangle showing Structures 11-14, looking west. Nueces River is visible through trees in background.

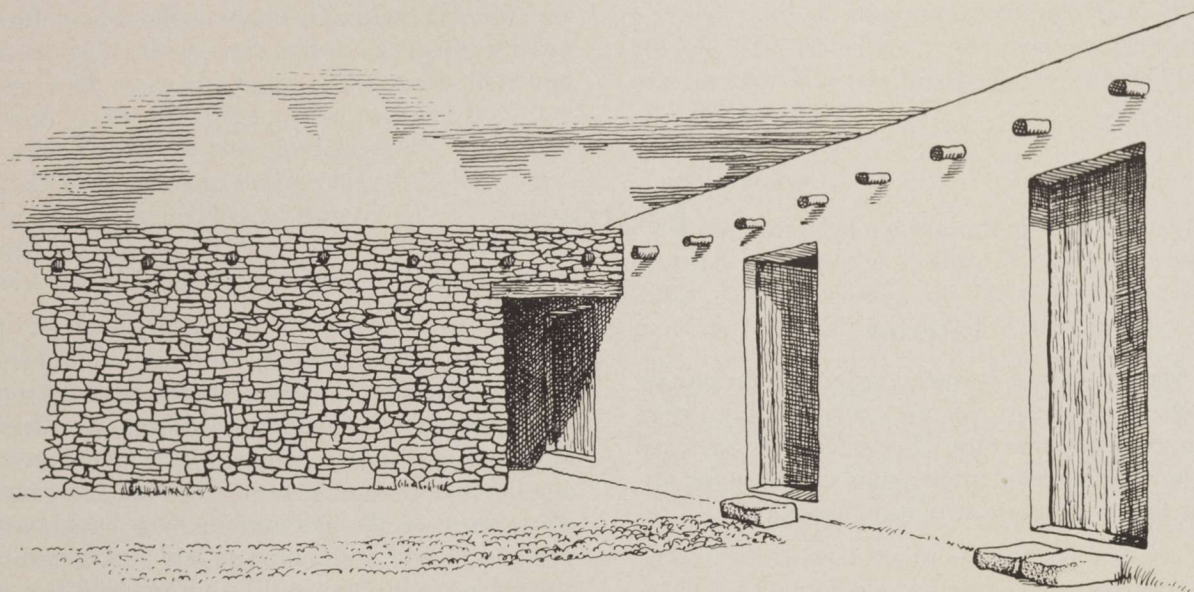
Fig. 26. Artist's reconstruction of northwest corner of quadrangle showing doorways (l. to r.) into Structures 13, 11, and 12. Looking northwest.

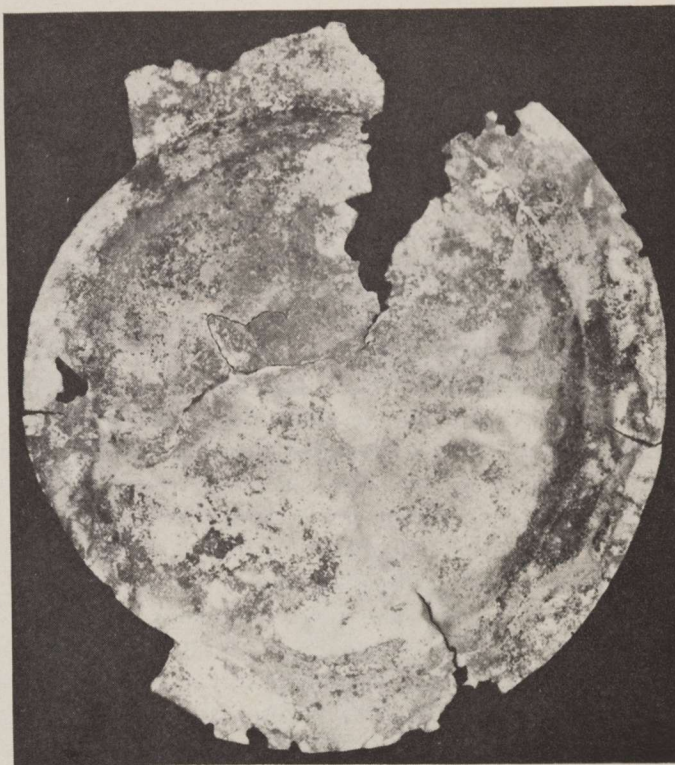
C

Fig. 27. Copper vessels. A, deep bowl; B, bowl with notched rim; C, plate.
